Al Larochelle 12-5-2019 Sig Sauer, Inc.

Pistol Inspection Report

The following pistol was sent to the factory from Oklahoma Highway Patrol for Evaluation for Unintentional Discharge: P320-9-OKDPS; Serial # 58C208343

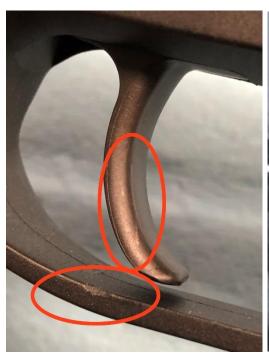
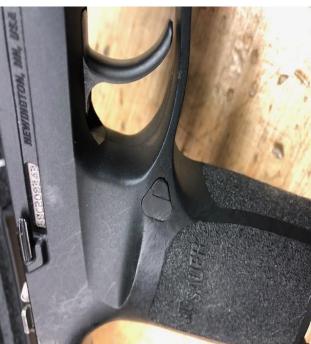
Inspected pistol and found that it appears a foreign object entered the holster causing the pistol to discharge. There are a lot of scratches and gouges on the right side grip module running from the trigger guard to the beaver tail. There is a scratch on top of slide. See Pictures Below
